eMate spring issue Root cause

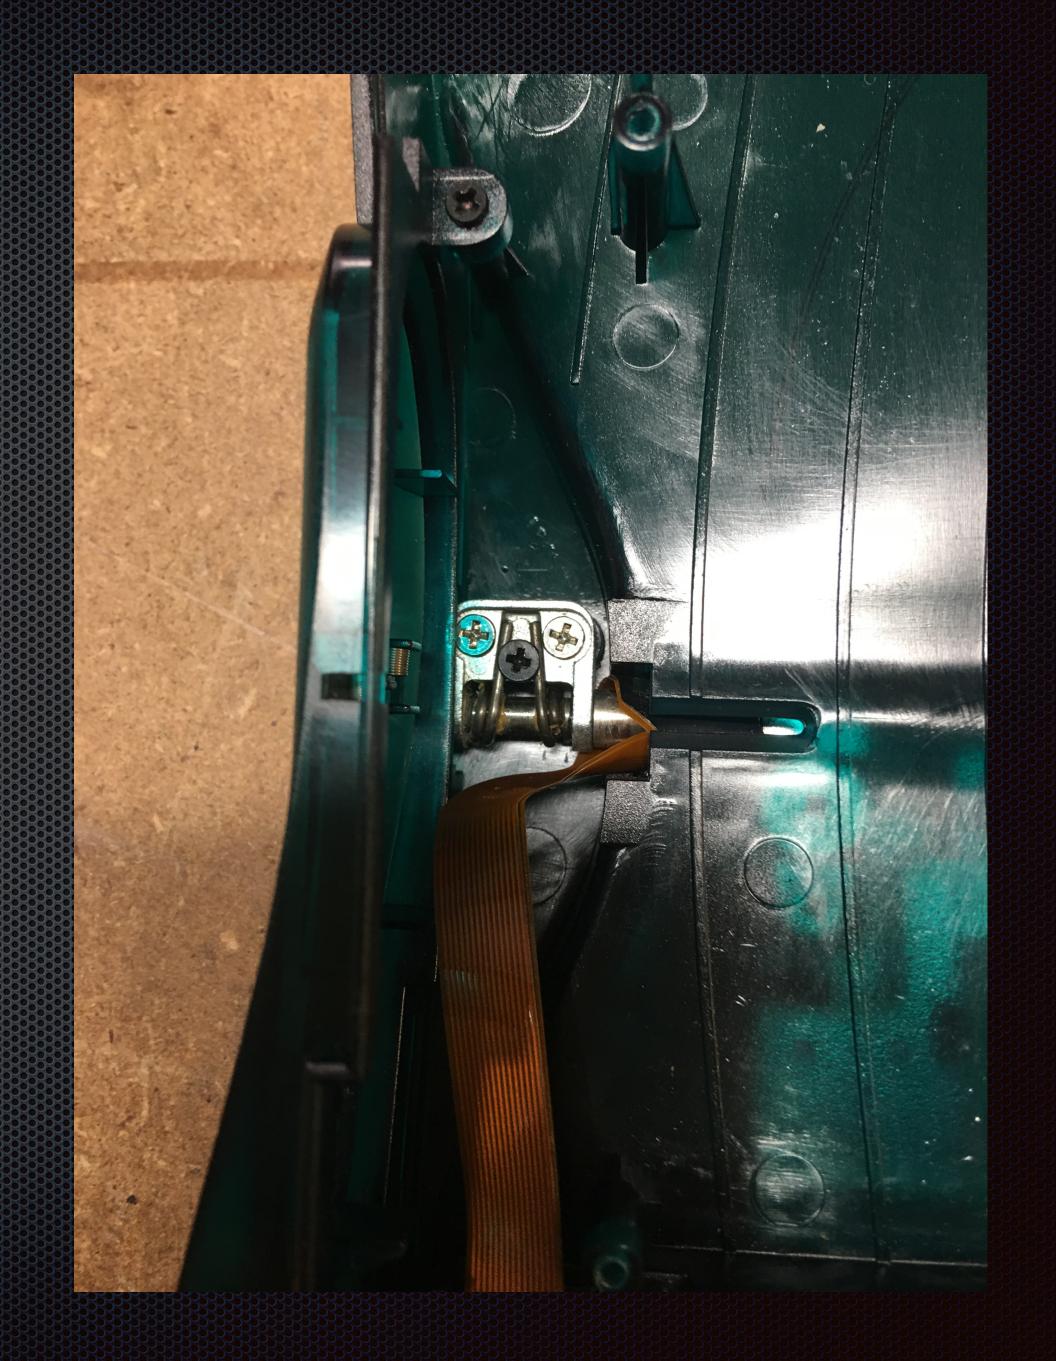
- A nicely behaved set of springs.
- But, with the potential for disaster.
- Constant use of the hinge will allow one or both spring ends to unseat allowing it to puncture the ribbon cable.

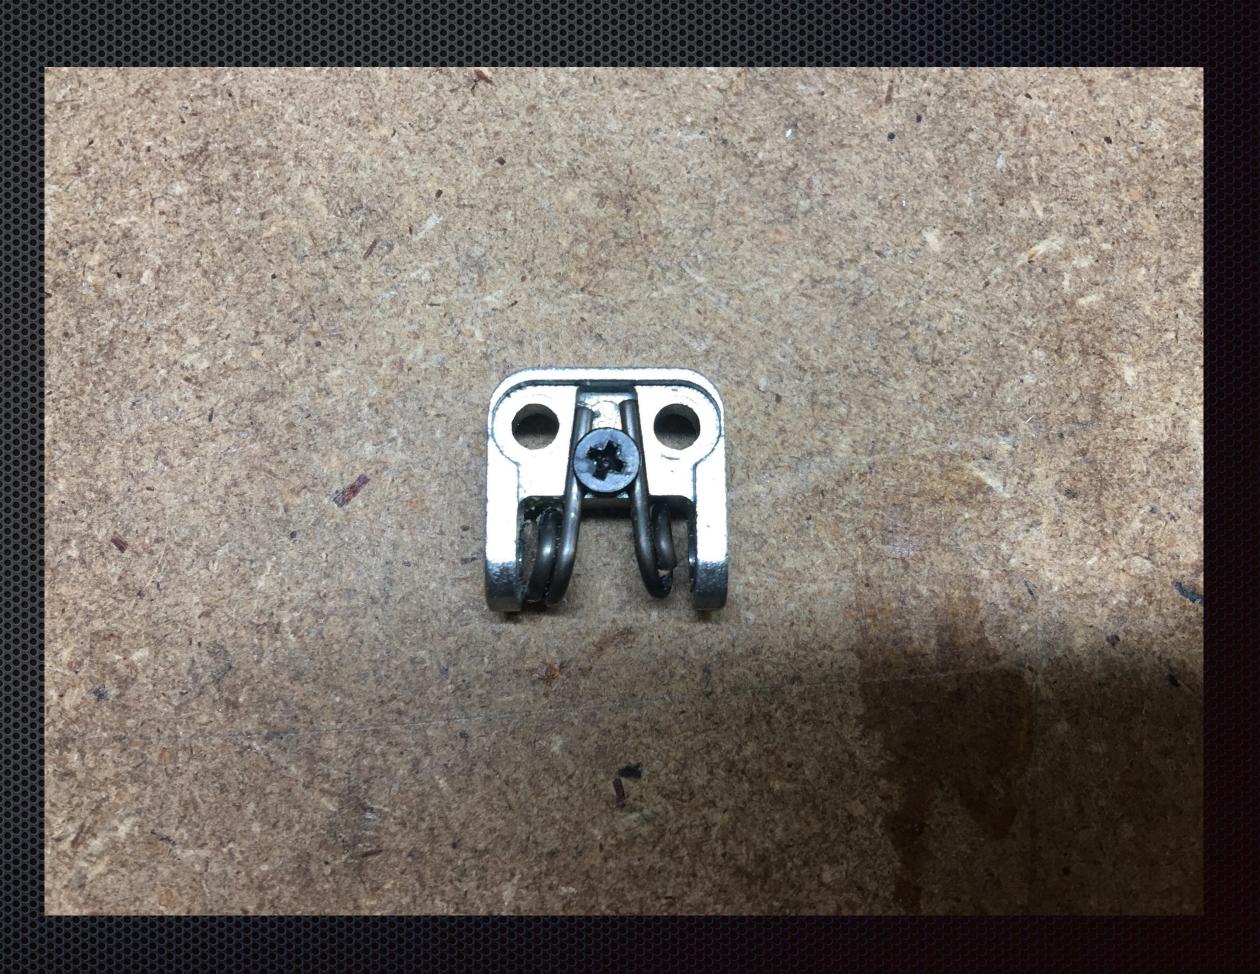
- The spring is actually two springs
- Either one can move past the retaining screw
